**Addendum to
Maryland Historical Trust
State Historic Sites Survey Inventory Form
CARR-595
SHOWERS-YINGLING FARM**

1. Name - Historic Name - Showers/Yingling Farm

CARR-595
Showers/Yingling Farm
Manchester vicinity
Carroll County
Manchester Quad

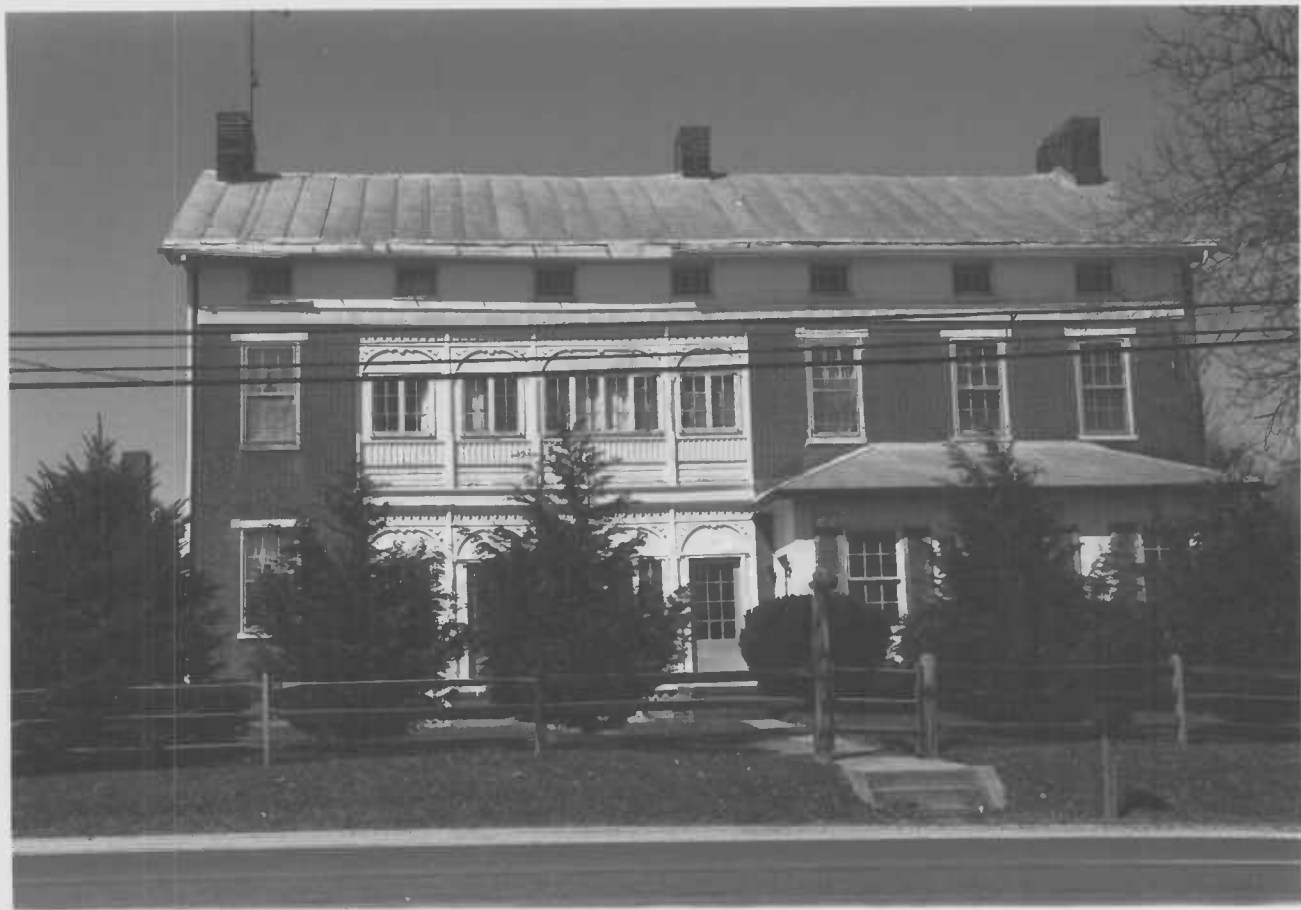
8/13 of 3x55

House, E elev

The exterior of the house is finished at its east front facade with polished bricks laid in stretcher bond. The brick of the other elevations is laid in 5/1 common bond. The lintels of the front facade bays are marked with Greek Revival-style cornerblocks decorated with roundels. The lintels of the side elevation bays feature cornerblocks without roundels. Plain brick relieving arches mark the rear elevation. Wooden Greek fretwork separates the second and third stories at the front facade. The third-story windows do not contain colored glass.

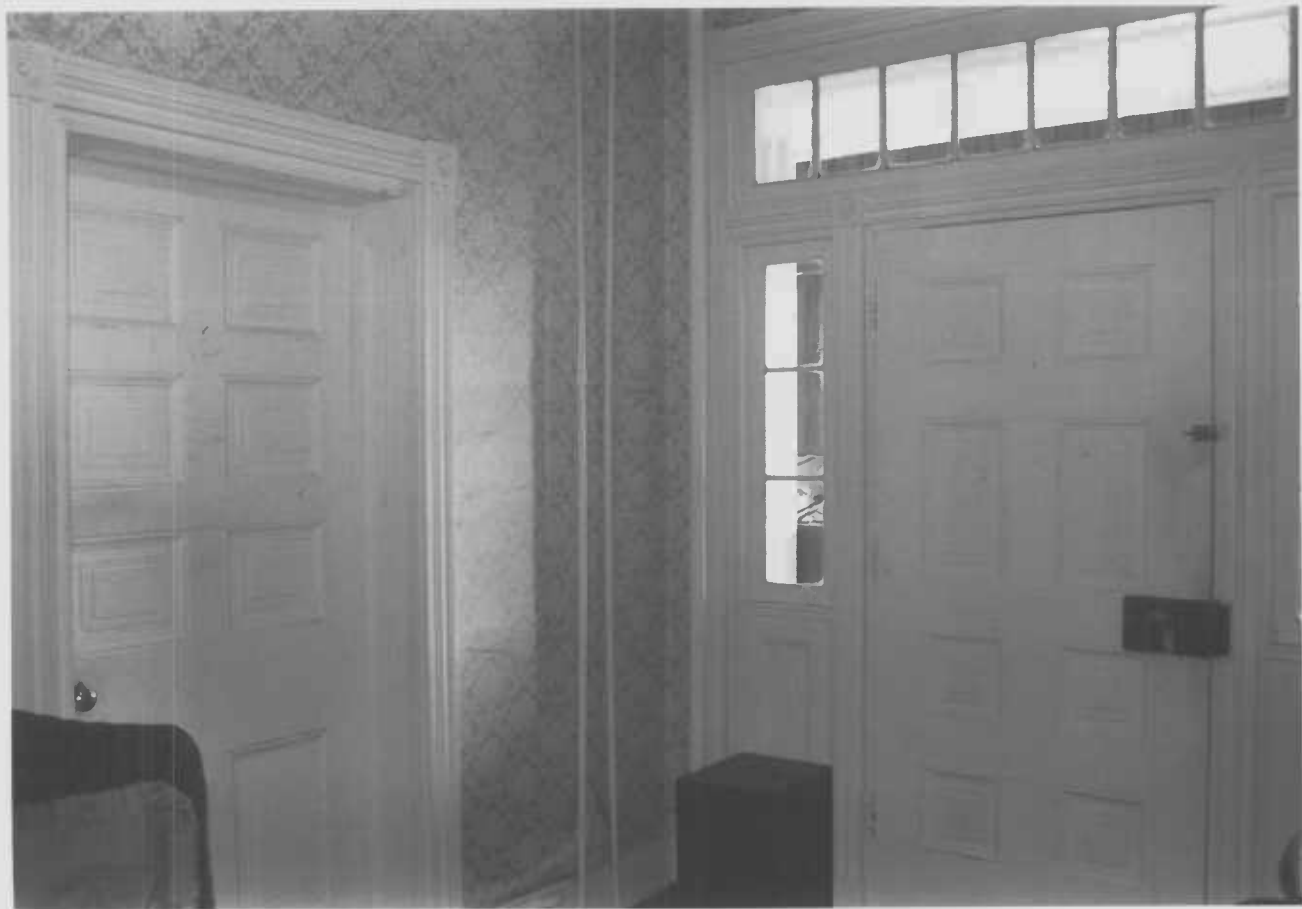
1 of 13, 3x5s

4/96
MARYLAND SHPO
House, Hallway

Greek Revival-style woodwork adorns the interior of the dwelling, which is largely intact. Original interior features include built-up post-and-lintel mantels; eight-panel doors with built-up, raised, symmetrical panels; symmetrical surrounds with corner blocks; and a principal stair winding up to the third floor with tobacco-stick-like balusters.

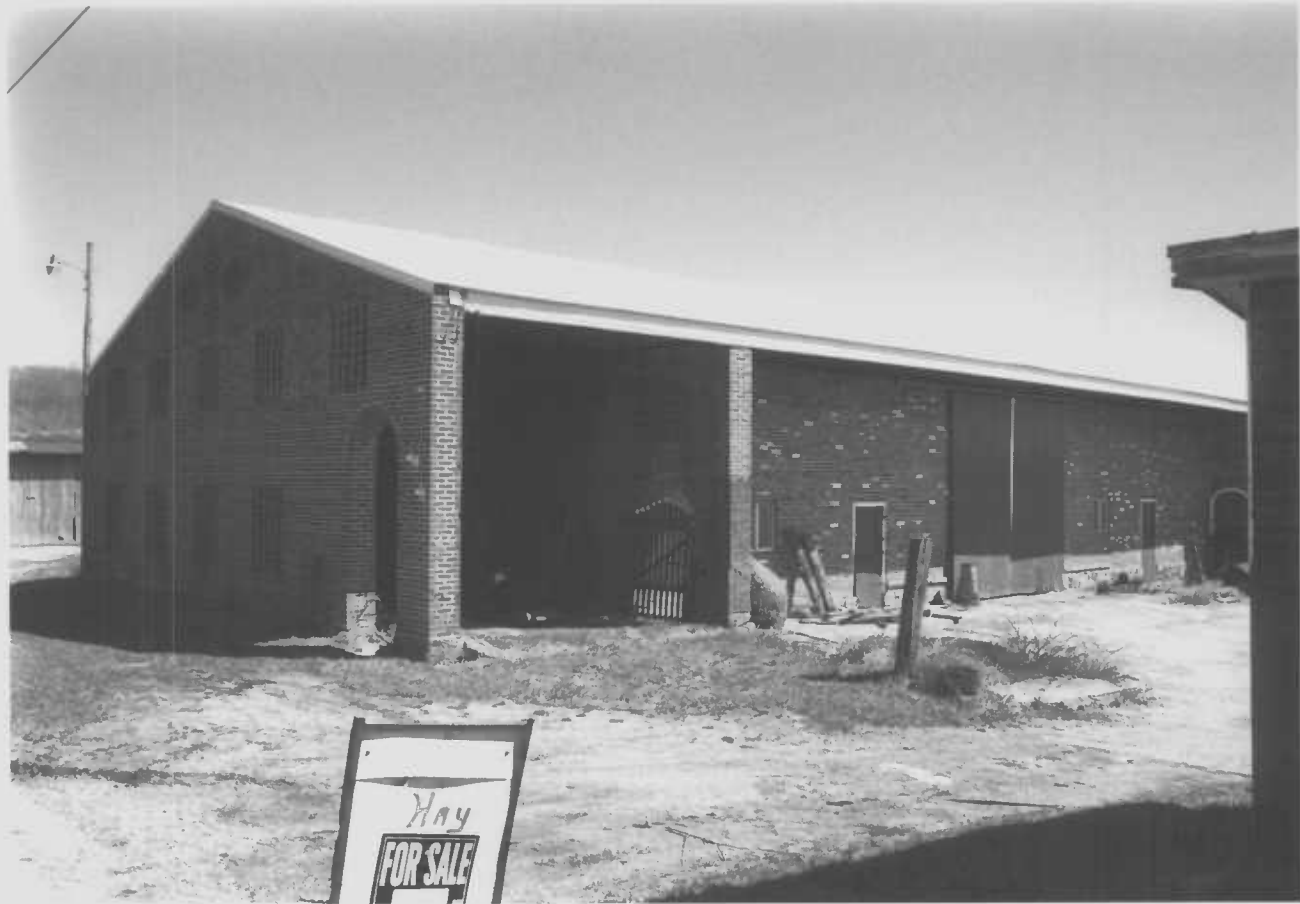
10/13 of 3x5s

BANK BARN FACING NE

The original brick bank barn that stood on this site was probably erected in the mid 19th century, around the same time as the house. According to Getty (1987:79), its bricks were made on the farm. At its west gable brick end facing the road it featured three tiers of rectangular open ventilators and open brick work in the gable of two diamonds and a star formed of four diamonds. (An early view of the barn prior to its reconstruction is pictured in Getty (1987:78).) The banked entrance of the barn was on the north. The wooden forebay section, which included long decorative louvered ventilators, was on the south.

In 1974 the barn was largely destroyed by fire, according to Dorothy Black, who occupied the farm with her husband, Cletus, at the time. Mr. Black rebuilt it in brick at a reduced height. He added a modern cinder-block-and-brick wall with open brick work at the west gable that largely mirrored, at a reduced height, the original wall. Part of the first story of that wall, retaining part of its open brick work, still stands behind the new wall. The banked entrance also remains on the north. The barn is, however, essentially a modern building.

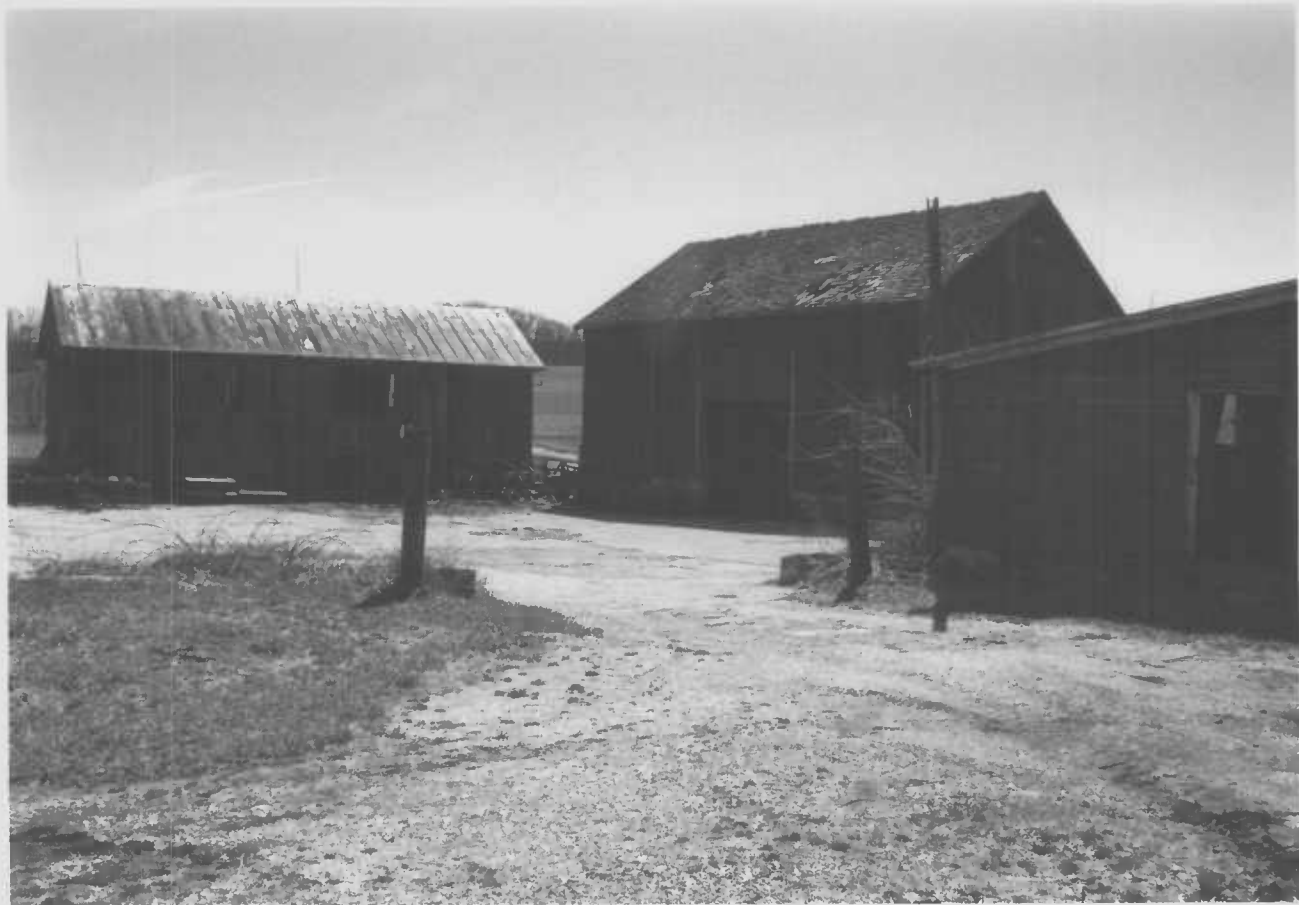
9/13 of 3x5s

OUTBUILDINGS FACING NE

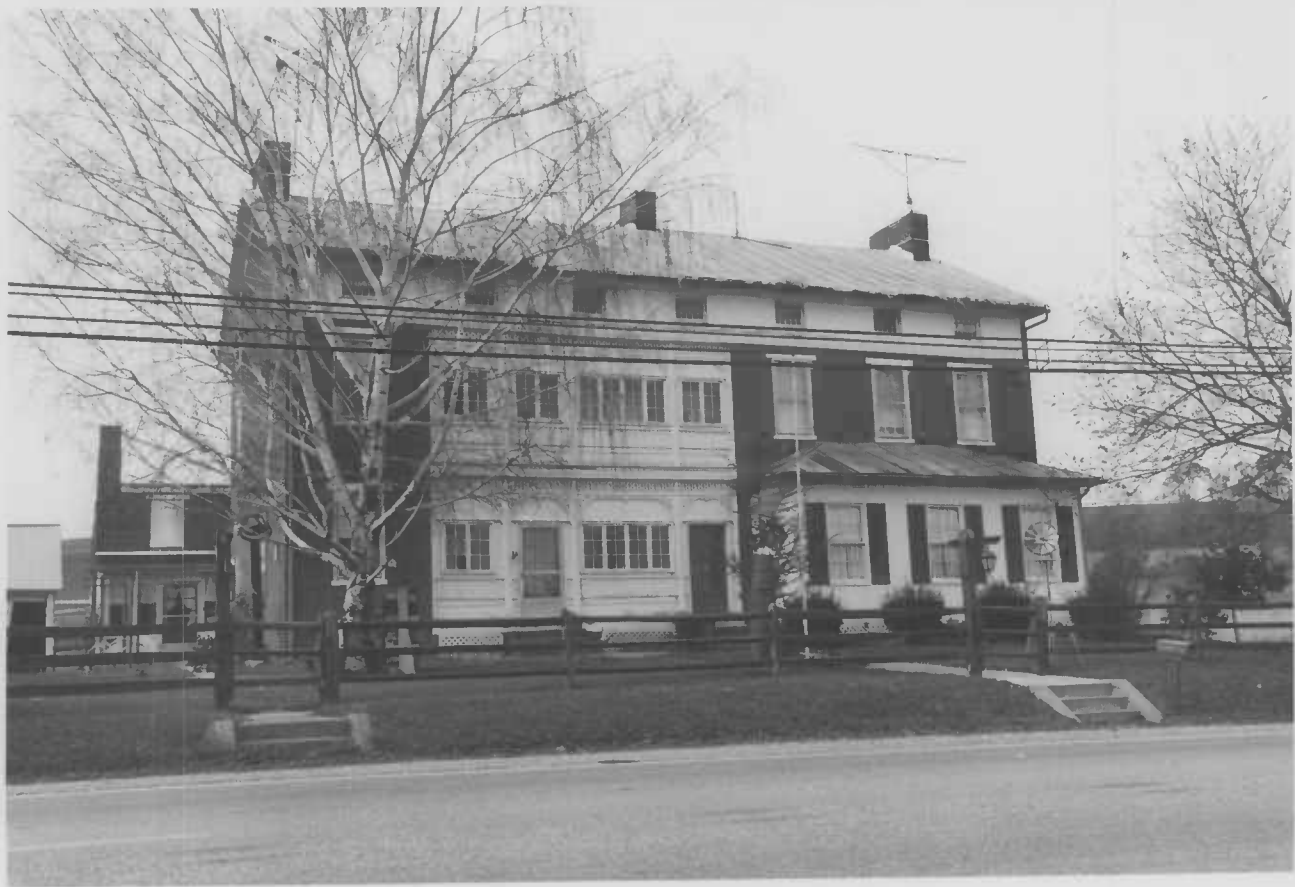
Carr-595
Showers/Yingling
Farm

view from
southeast

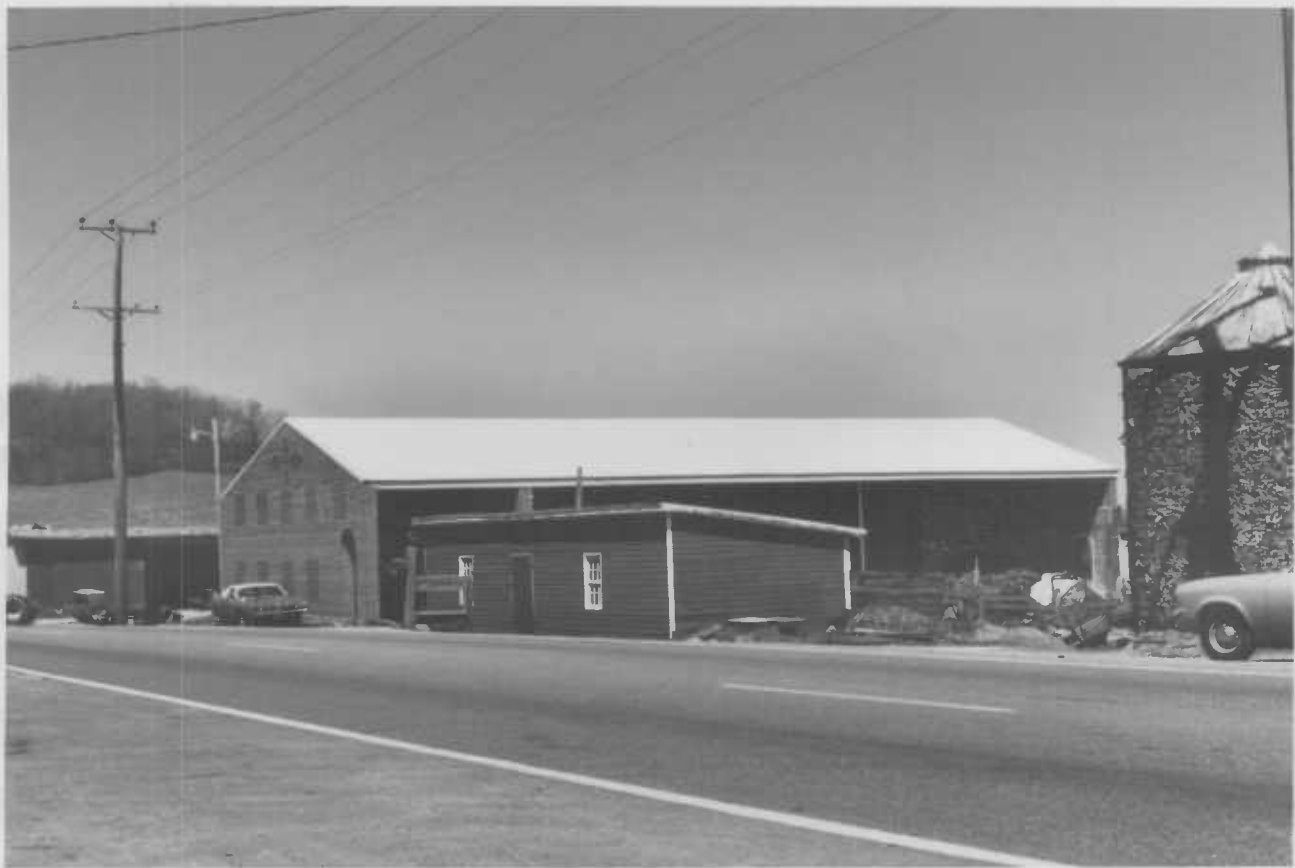
Carr-595

brick end
barn, from
southwest

Across the road is a large group of barns and sheds; of particular interest is the large brick end barn with patterned brickwork vents, of Pennsylvania influence and rare in the vicinity.
